AN EVALUATION OF EXPANDED METAL GLARE SCREEN
ON THE NEW JERSEY CONCRETE MEDIAN BARRIER

Edgar J. Hellriegel
Principal Engineer, Transportation Research

February 1978

Final Report

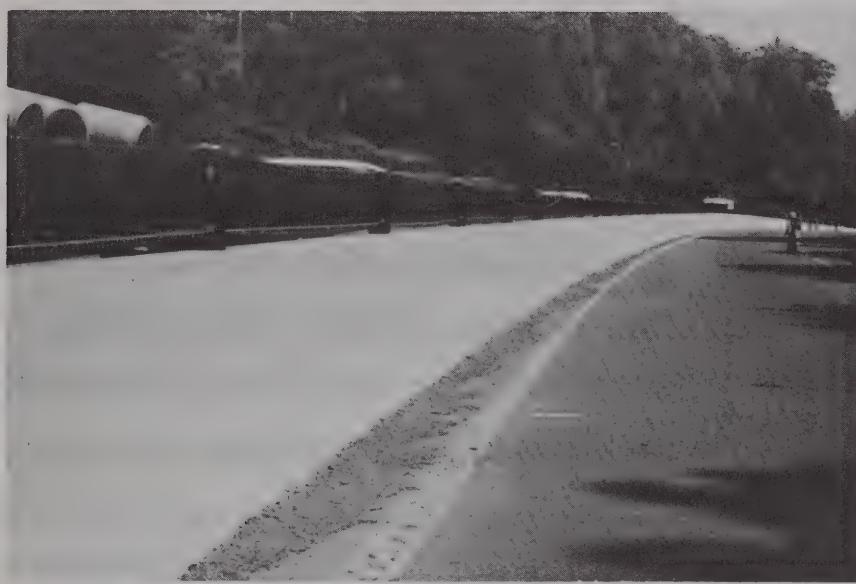
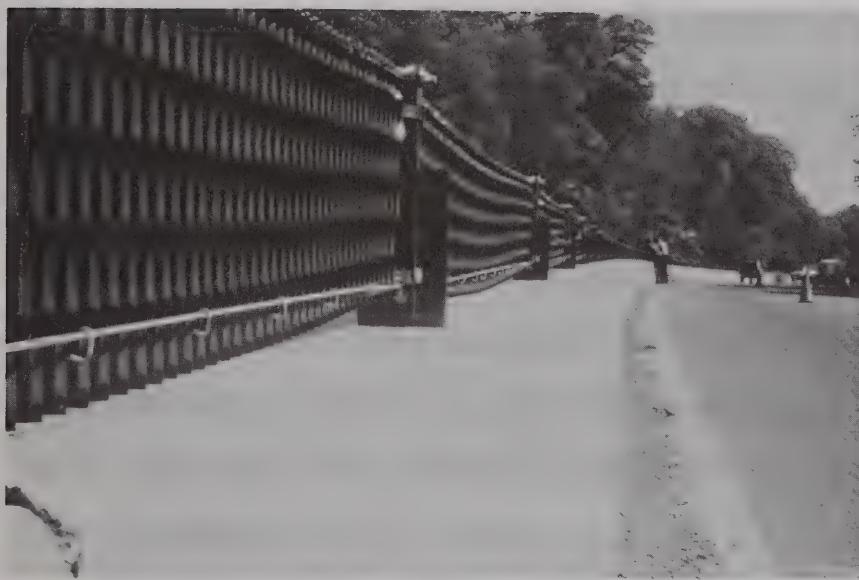
Figure 1 - Test Site

An eleven hundred foot horizontal compound curve on U.S. 22 in Scotch Plains was selected as a test site for the evaluation (Figure 1). This location had the effect of shining the headlights of the eastbound vehicles directly into the eyes of the westbound motorists. Furthermore, the roadway is densely bordered by trees with no commercial or street lighting. In inclement weather the wet barrier displays very little diffuse reflectance and in conjunction with the oncoming glare, the barrier is practically invisible to motorists.

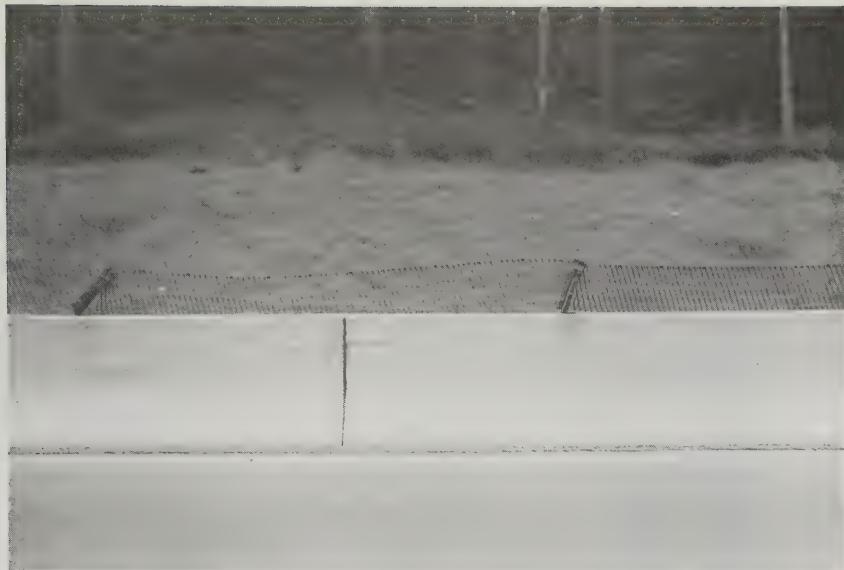
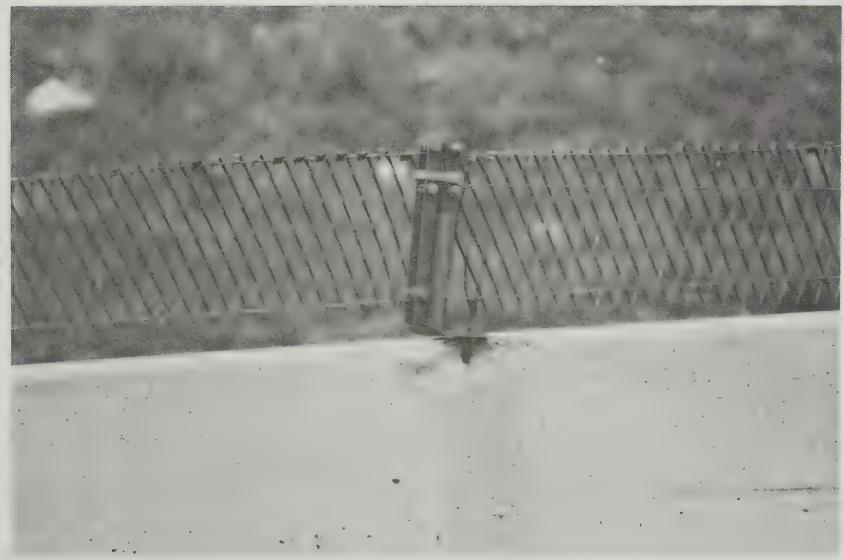
Figure 3 - Glare Screen Impact Damage Associated with L Bracket.

2. The concern for the width of the L bracket proved to be real. In four of six encroachments on the barrier, the L bracket was contacted by the vehicle. This resulted in damage not only to the bracket(s), the screen(s), and the tension wires but caused spalling of the concrete barrier by the anchor bolts, (See Figure 3). Contrarily, there were three hits on the barrier within the boundaries of the thin line post system (Appendix B) without causing any damage to the glare screen (See Figure 4).
